## **Realistic Safe-Separation Distance Determination for Mass Fire Hazards**

by  
Thomas L. Boggs  
*New Directions Technology, Inc.*  
*Ridgecrest, CA 93555*

**MARCH 2013**

NAVAL AIR WARFARE CENTER WEAPONS DIVISION  
China Lake, CA 93555-6100

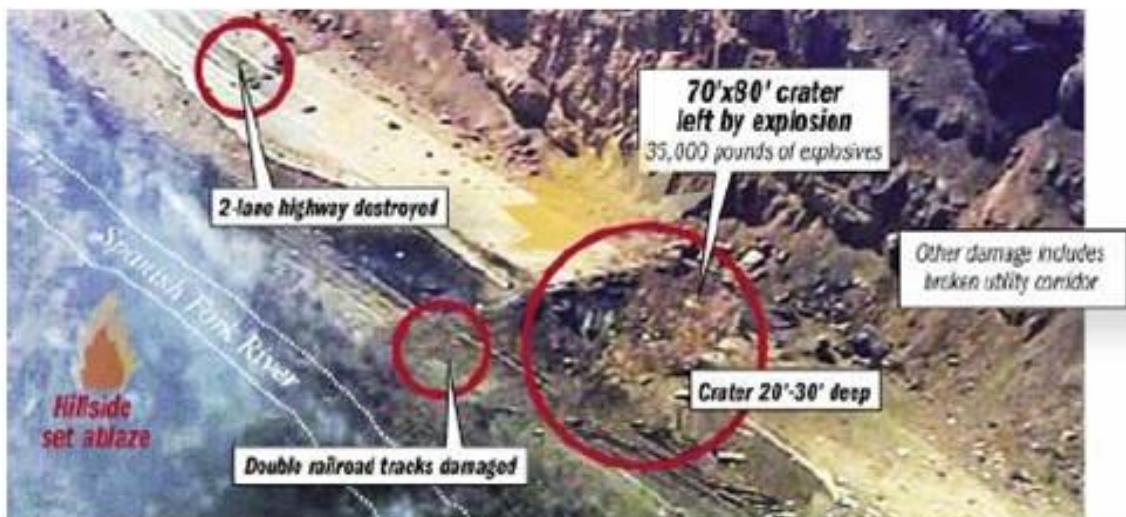
An accident occurred on Route 6 in Spanish Fork Canyon near Thistle, Utah, on 9 August 2005. A tractor-trailer carrying 35,500 pounds of HD 1.1 commercial booster explosives went off the road, overturned, and caught fire. Rescuers were able to free the driver and his passenger. The dazed driver told rescuers that the trailer was carrying explosives. People were in the process of evacuating when the boosters exploded/detonated. Figure 89 shows an aerial view of the accident site. The crater that was produced (Figure 90) was 21 meters (70 feet) wide and 9 meters (30 feet) deep. There were no fatalities and 11 were injured.

FIGURE 89. Aerial View of Accident Site in Spanish Fork Canyon, Utah.

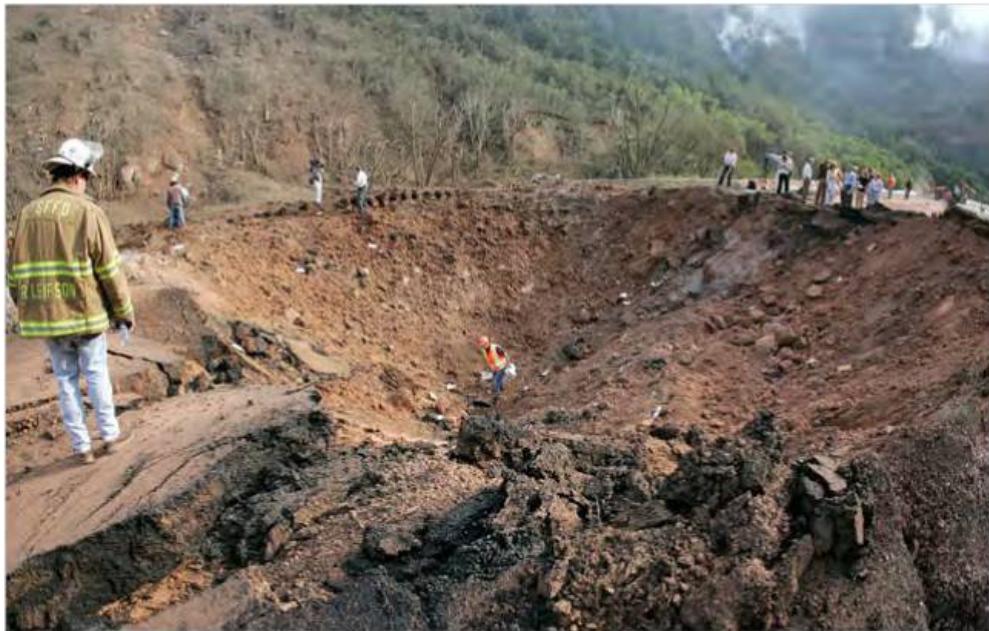
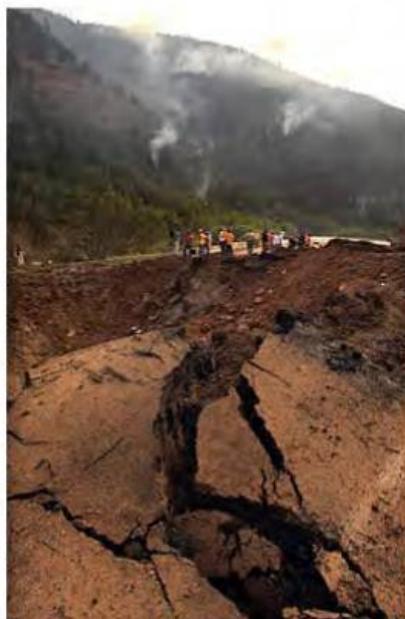
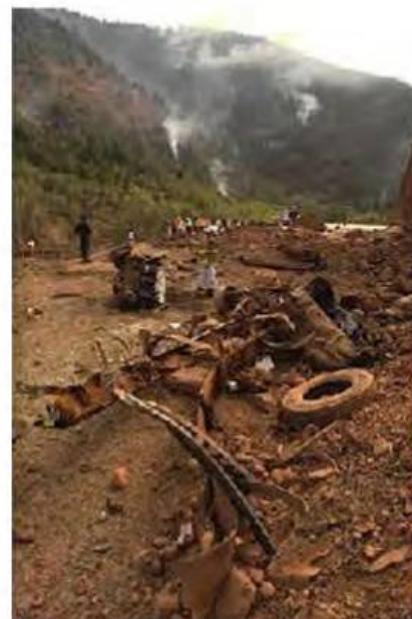
**Crater, 20-35 feet deep**

**Crater and  
damaged roadway**

**Remains of truck**

FIGURE 90. Accident Involving 35,500 Pounds of HD 1.1 Commercial Booster Explosives That Occurred in Spanish Fork Canyon Near Thistle, Utah, on 9 August 2005.

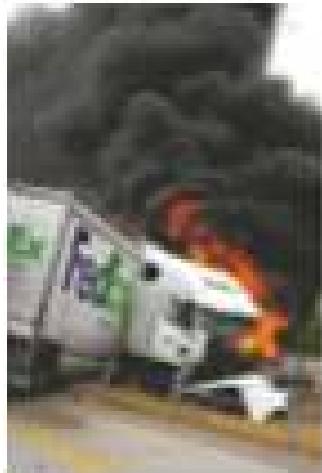
FIGURE 91. Crash Scene on Interstate 80,  
13 June 2009.

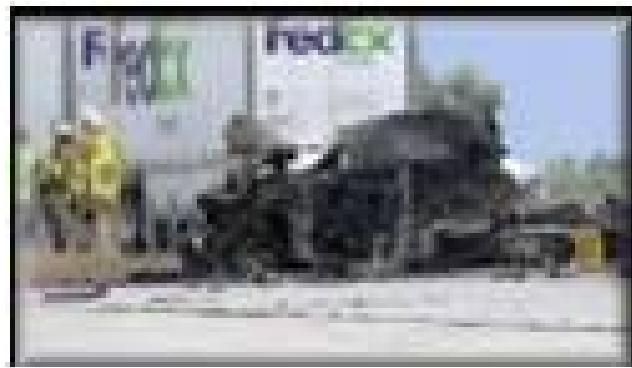
FIGURE 92. Crash Scene on Interstate 80, 13 June 2009.

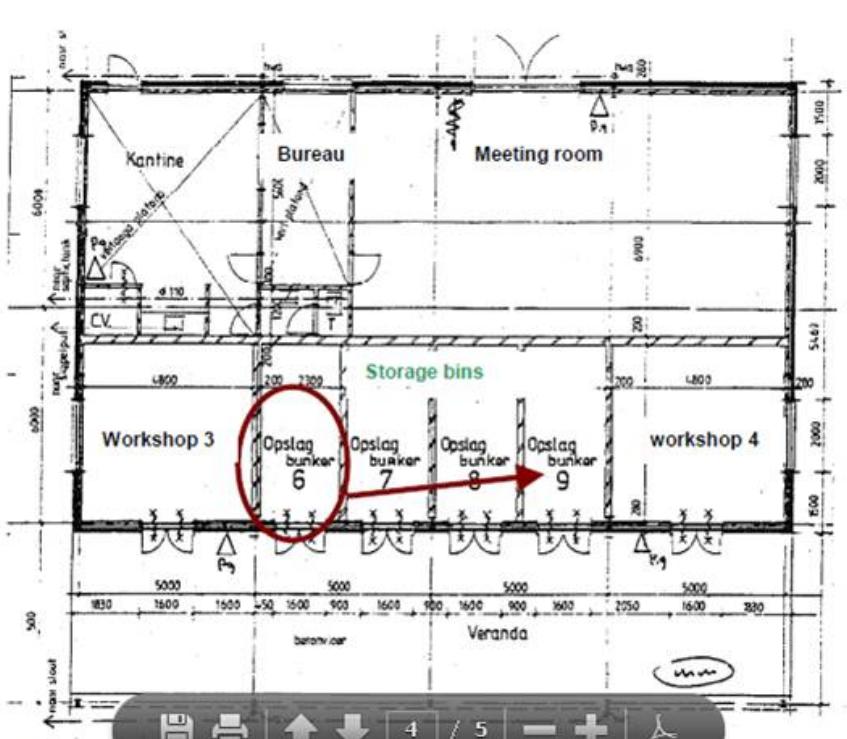
Plan of the «new building» leveled by the explosion. It most likely started in bin 6 and spread on to the other bins.]

FIGURE 93. Schematic of the New Building, Culemborg, the Netherlands as it Existed Before Accident.

In the investigation, definitive indications for the direct cause of the explosion were not found. However, a reasonable explanation was that the explosion probably started in storage room 6, immediately followed by explosions in storage rooms 7, 8, and 9.

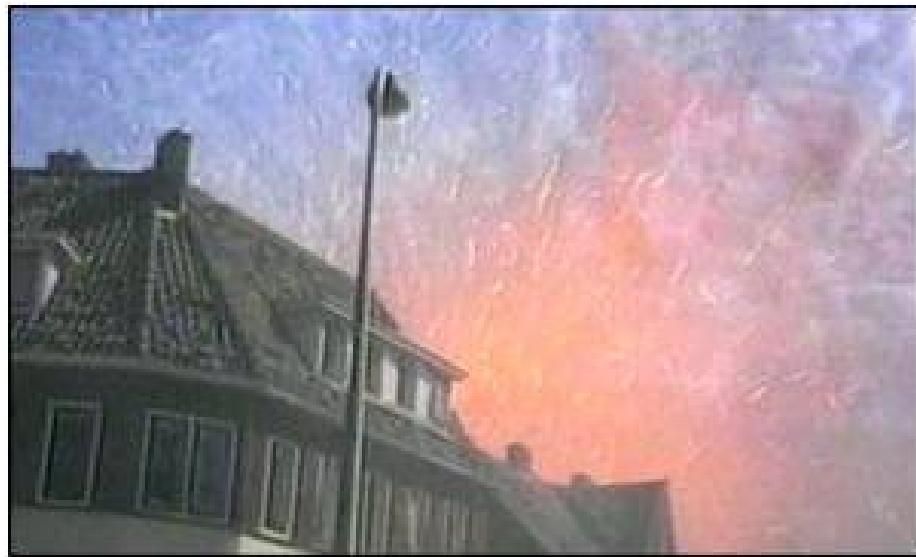
FIGURE 95. Fireworks Explode at Enschede and  
Flames Extend 40 Meters Into the Air.

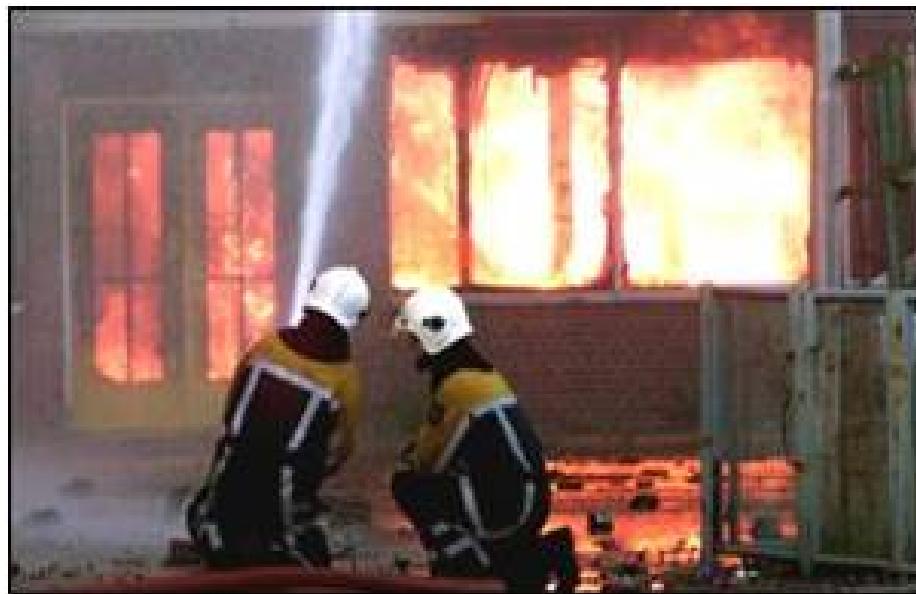
FIGURE 96. Fire Crews Battle to Bring the  
SE Firework Blaze Under Control.

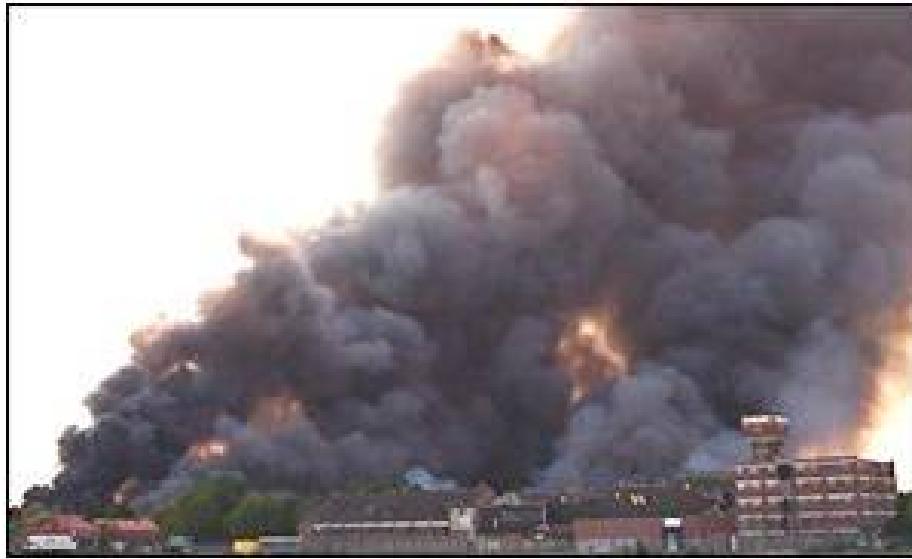
FIGURE 97. Plumes of Smoke Cover Enschede.

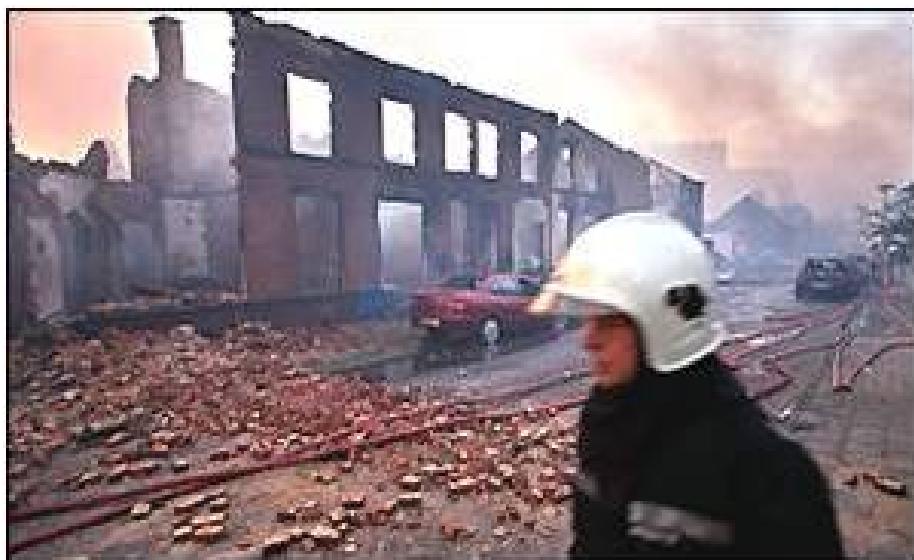
FIGURE 98. Aftermath of the Blaze Looked Like a Bomb Site.

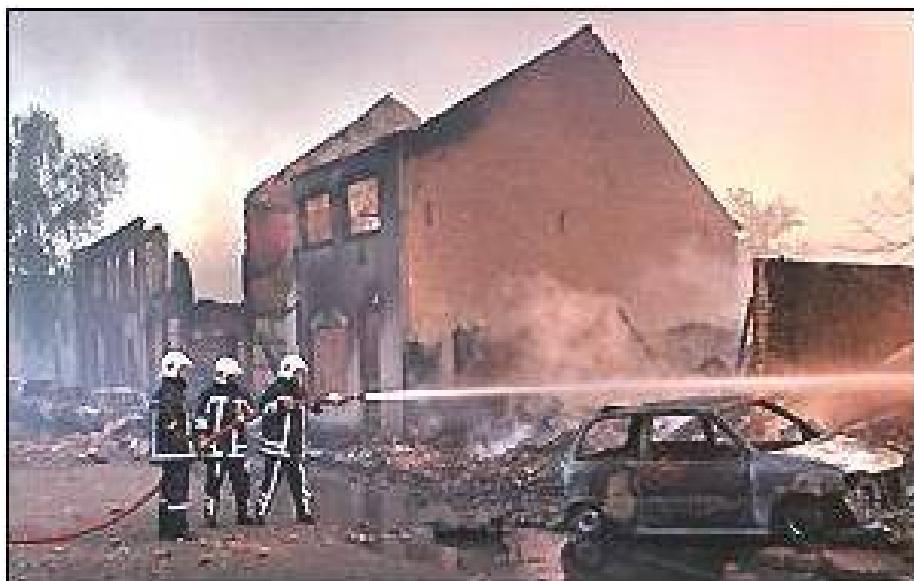
FIGURE 99. Cars and Homes Destroyed in the Explosion at Enschede.

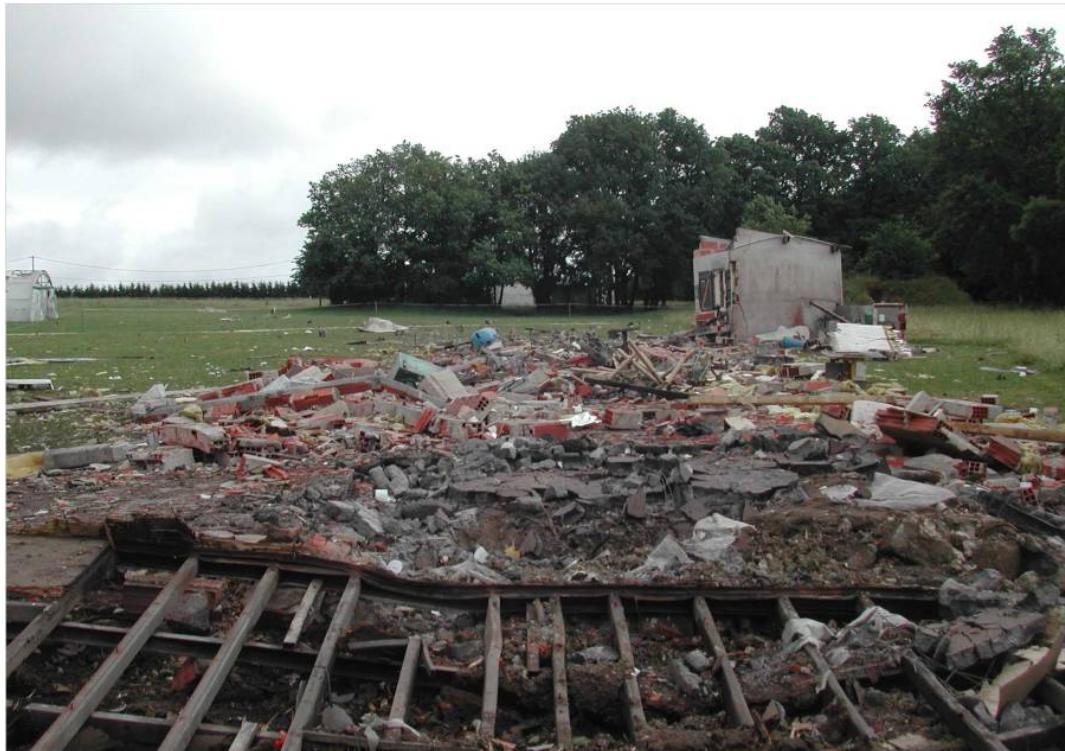
FIGURE 103. Remains of Building 9 After the Accident.

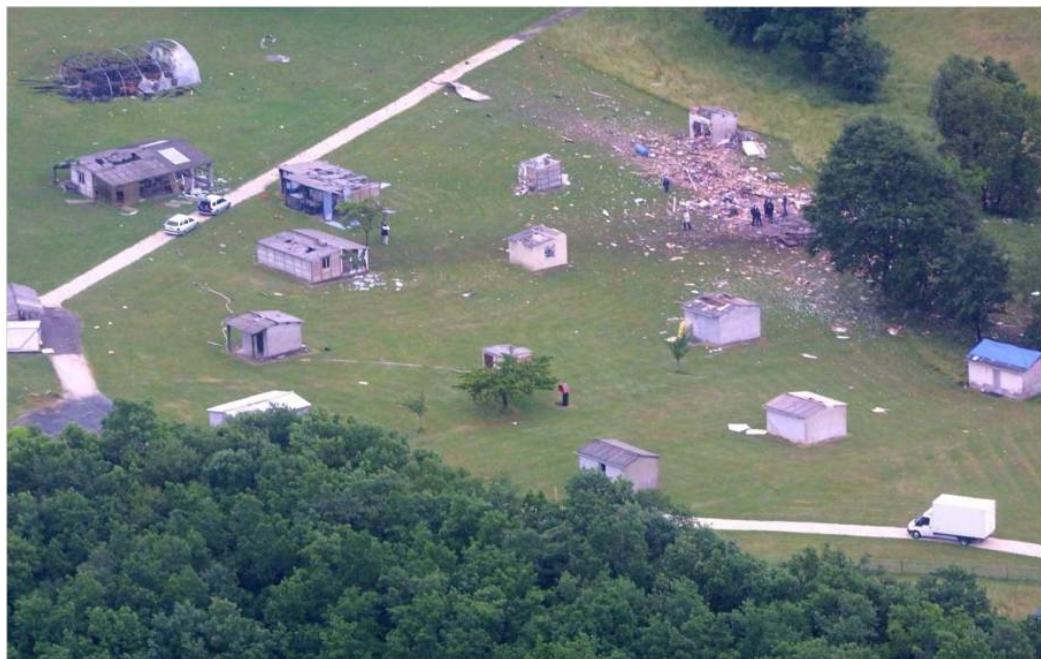
As shown in Figures 103 and 104, building 9 was completely destroyed. The walls were completely blown out and there was a 3- by 1.5-meter by more than 50-centimeter deep crater near the outside wall in the shell store room (9A).

FIGURE 104. Aerial View Showing Where Building 9  
Had Been Located Before the Accident.

Figure 104 also shows that the explosion caused damage to the neighboring buildings due to overpressure and fragments. Wall and roof debris from Building 9 was found up to 160 meters away.

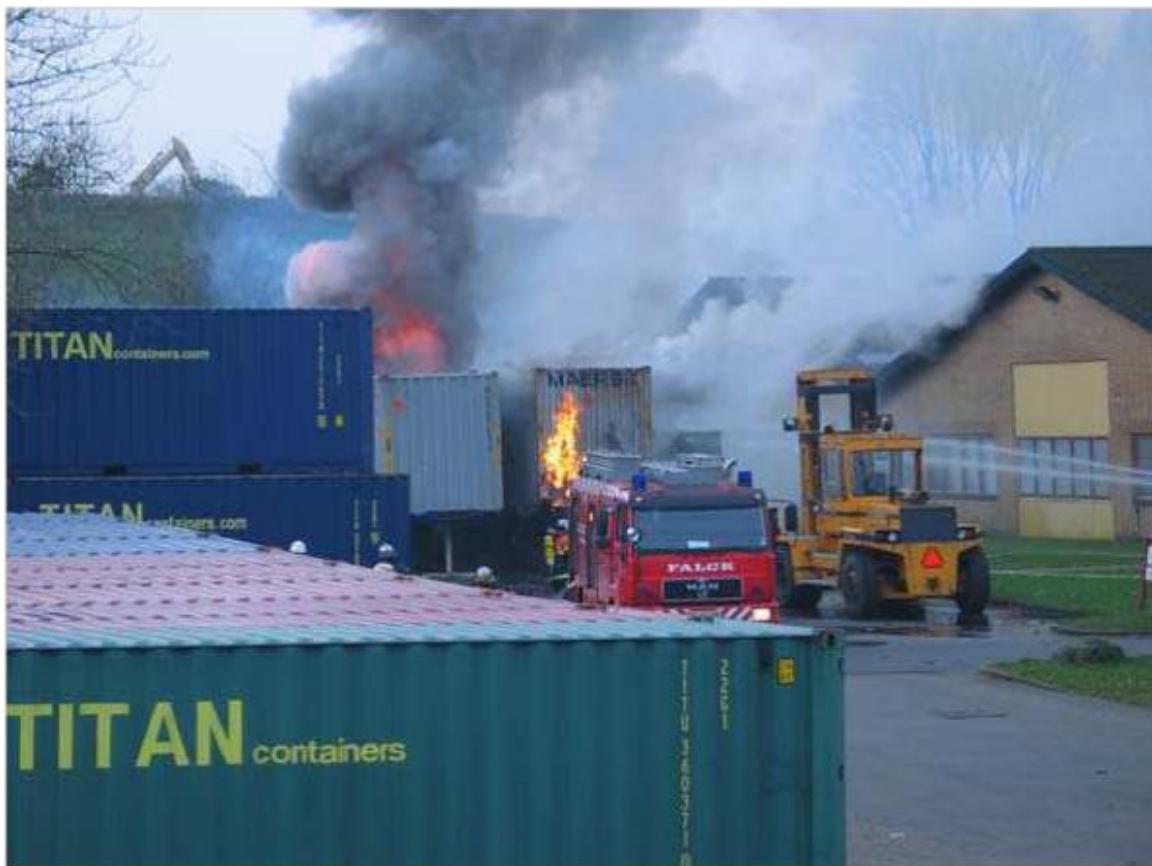
FIGURE 107. Attempts to Put Out the Fire in the Containers.

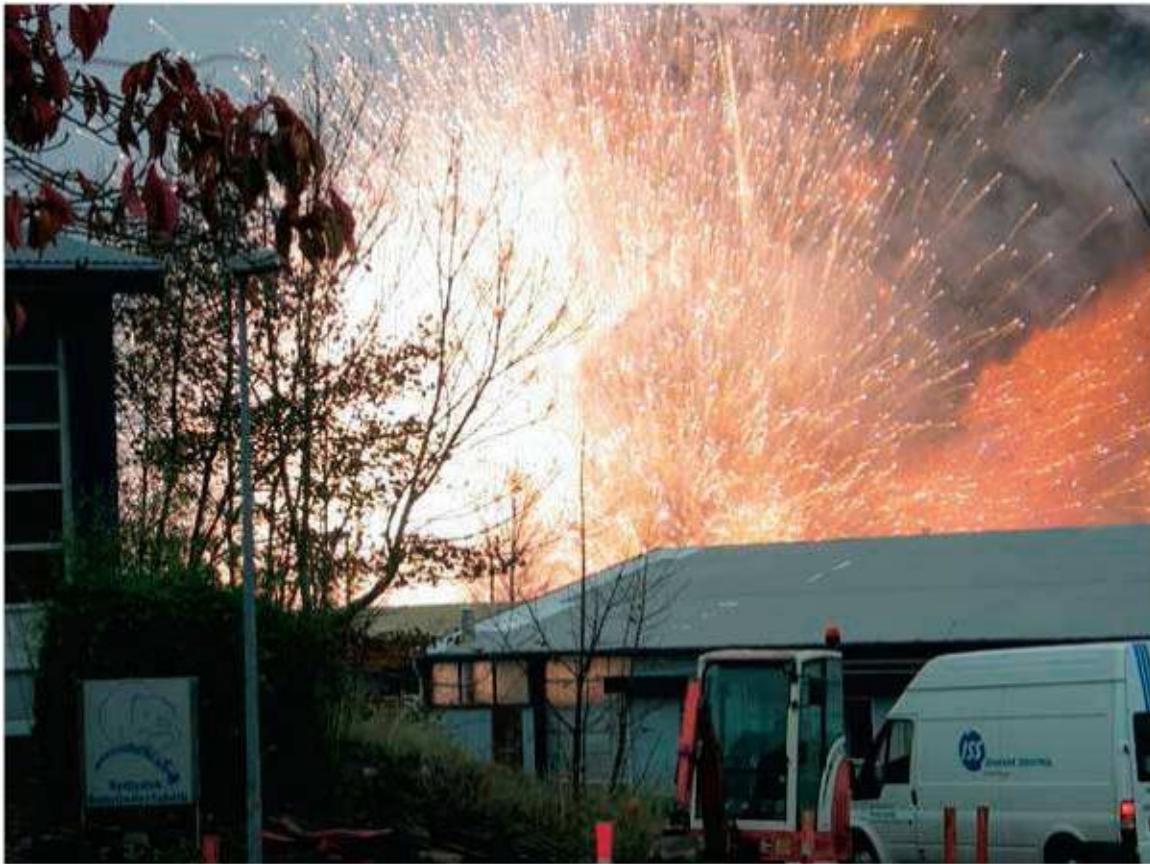
At 3:25 p.m. a major explosion occurred in the area of the burning containers with results shown in Figure 108. The explosion occurred much to the surprise of the rescue workers because there were no signs of an increase in the intensity of the fire immediately preceding the explosion. There were contradicting versions of what happened at 3:25 p.m. Some reports said that container 2 exploded. However, that was also questioned because container 2 was two-thirds empty at the start of the accident (2:00 p.m.) and was on fire for about 90 minutes by 3:25 p.m. It is hard to imagine that any material still on fire in container 2 at 3:25 p.m. could have reacted so violently and caused so much damage. It is more likely that during the 90 minutes between the initial fire and the explosion, one of the 20-foot ISO containers between containers 1 and 2 and buildings 1 and 2 were heated and then exploded at 3:25 p.m. Post accident analysis showed no crater at the location of the containers.

FIGURE 108. Explosion Occurred at 3:25 p.m.; Approximately 1 Hour 25 Minutes After the Initial Fires Broke Out.

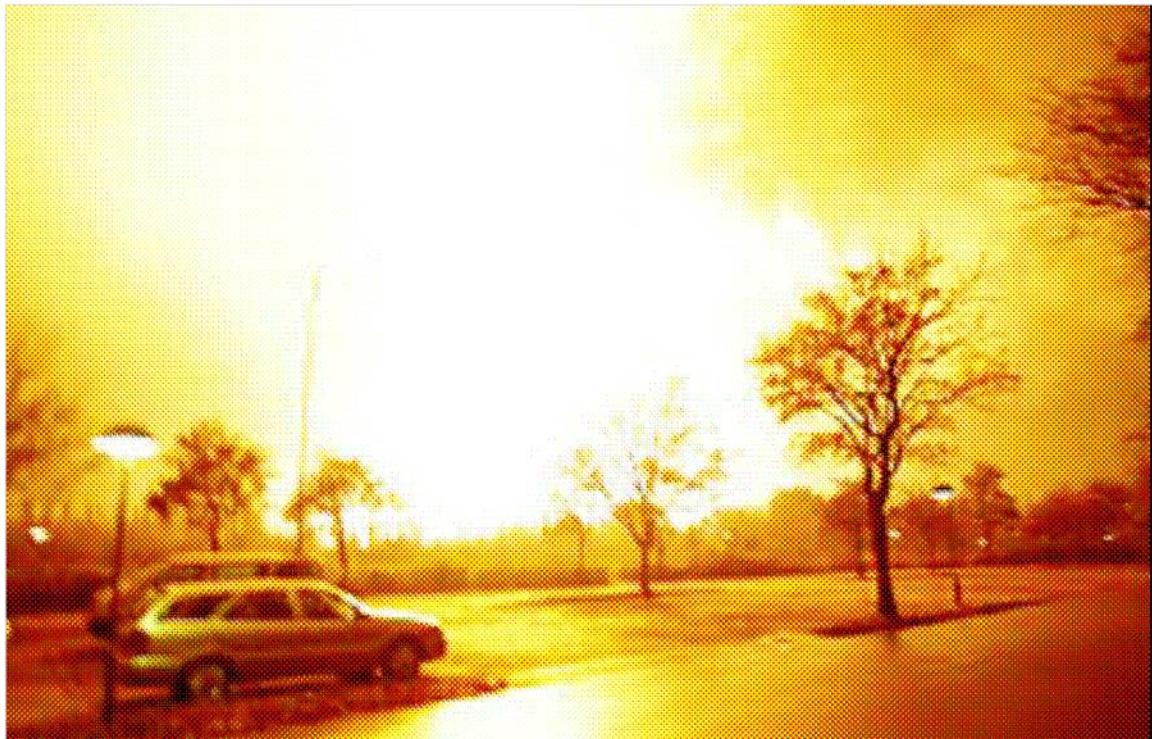
Three major explosions that resulted in a spectacular fireball (Figure 109) of several meters in diameter occurred at 5:45 p.m. These explosions were presumed to have occurred in buildings 6 and 7. These buildings contained 150 tonnes of fireworks.

FIGURE 109. Explosions That Occurred at 5:45 p.m.

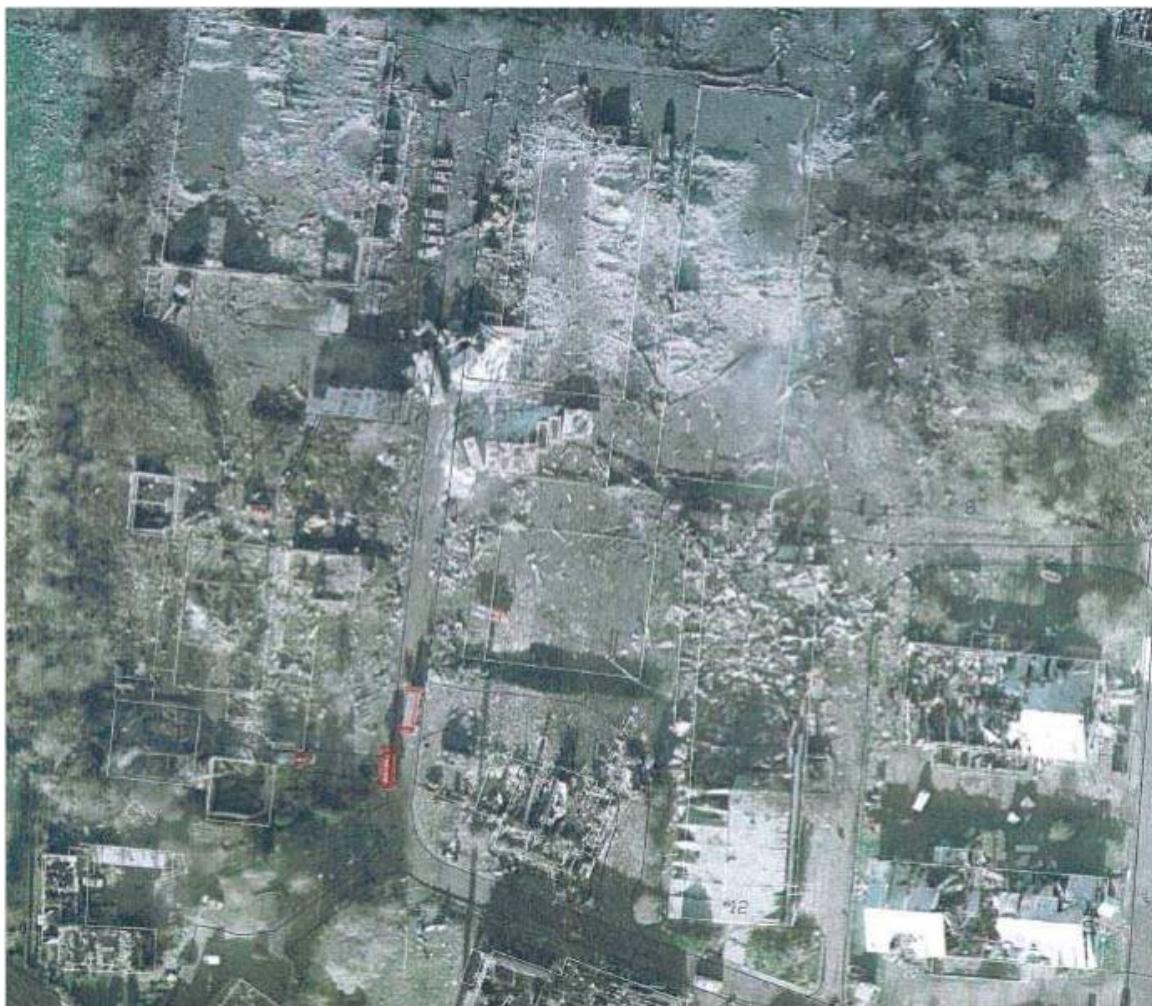
FIGURE 110. Aerial View of the Site at Fireworks Site Near Kolding After the Accident.

A 2 meters squared by 15 centimeters thick fragment of a concrete wall, weighing approximately 1 tonne, was found 150 meters from building 6. Debris of the buildings was found over 1,000 meters from the disaster. The damage to buildings was approximately 100 million euros.

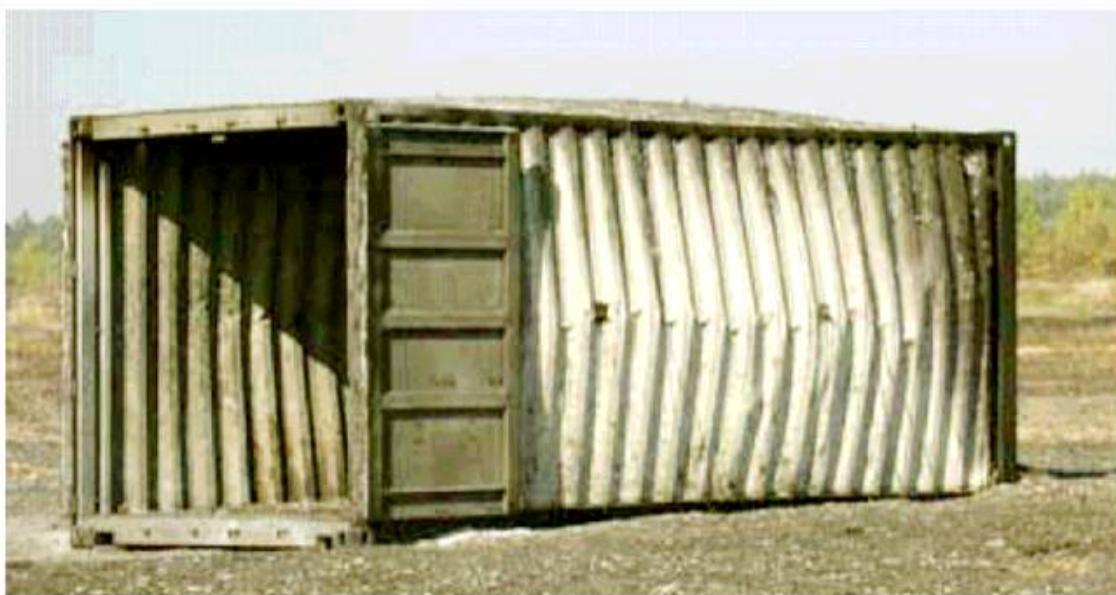
The damage to the containers varied from simple bulging of container walls to destruction of the container to fragmentation of the container and projection of fragments, as shown in Figures 117 through 119.

FIGURE 117. Damage to ISO Container From the 75-mm Shell Test.

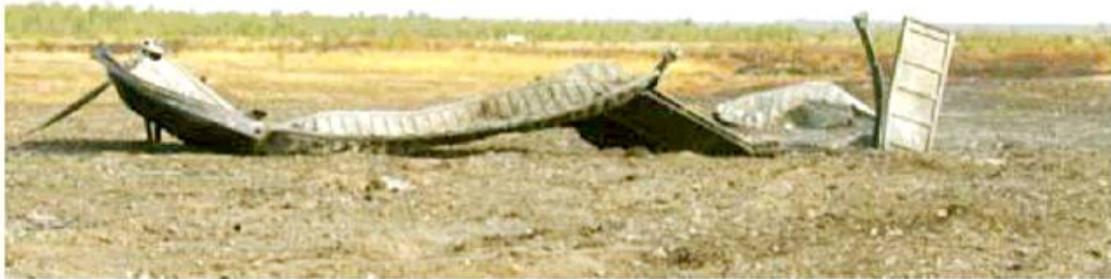
FIGURE 118. Damage to ISO Container From the 150-mm Shell Test.

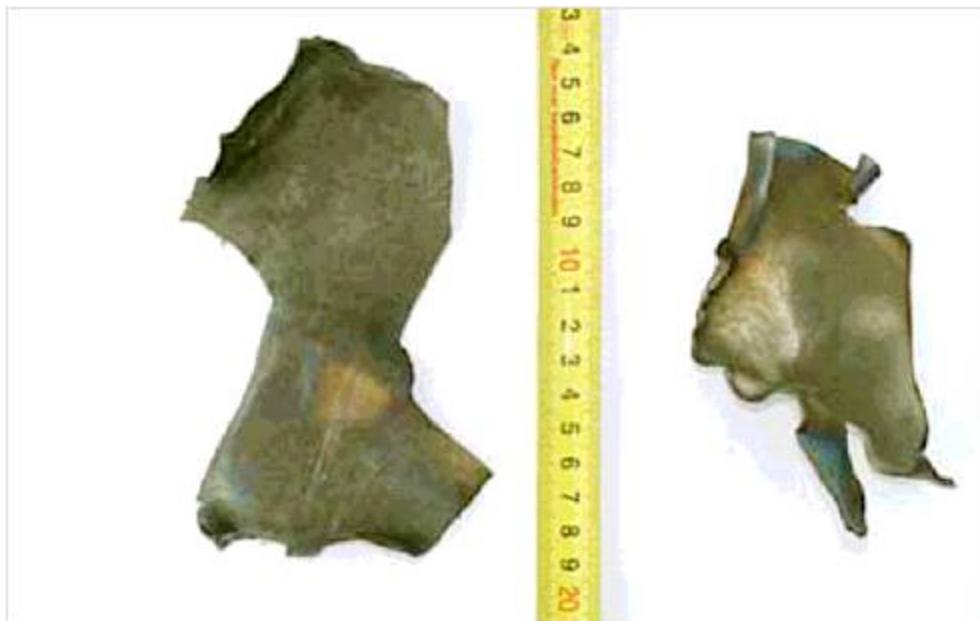
FIGURE 119. Fragments From the ISO Container From the Waterfalls Test.

The results of the tests with the waterfall fireworks are very interesting. The small-scale UN series 6 results would classify these materials as HD 1.3, yet the full-scale tests resulted in mass explosion. The obvious question is what did the WP 8 tests show? The WP 8 tests showed that the connected waterfalls had a maximum  $dp/dt$  of  $1.4E+08$  kPa/s and a specific impulse of 0.2 kPa.s/kg. These values are in the mass explosion area of Figure 115, so the large-scale test results should not be surprising. Similarly the 150-mm color shells using the UN series 6 tests would classify these materials as HD 1.1, yet there was no explosion until extra confinement was provided to the ISO container by earth covering. The extra confinement by earth covering produced a mass explosion. So once again, what were the results from the WP 8 tests? The WP 8 results were  $4.0E+05$  kPa/s and 47.1 kPa.s/kg for the WP 9 150-mm shells, and  $2.9E+05$  kPa/s and 66.3 kPa.s/kg for the WP 6 150-mm shells. Both of these sets of values place the 150-mm shells in the non-mass explosion area of Figure 115.

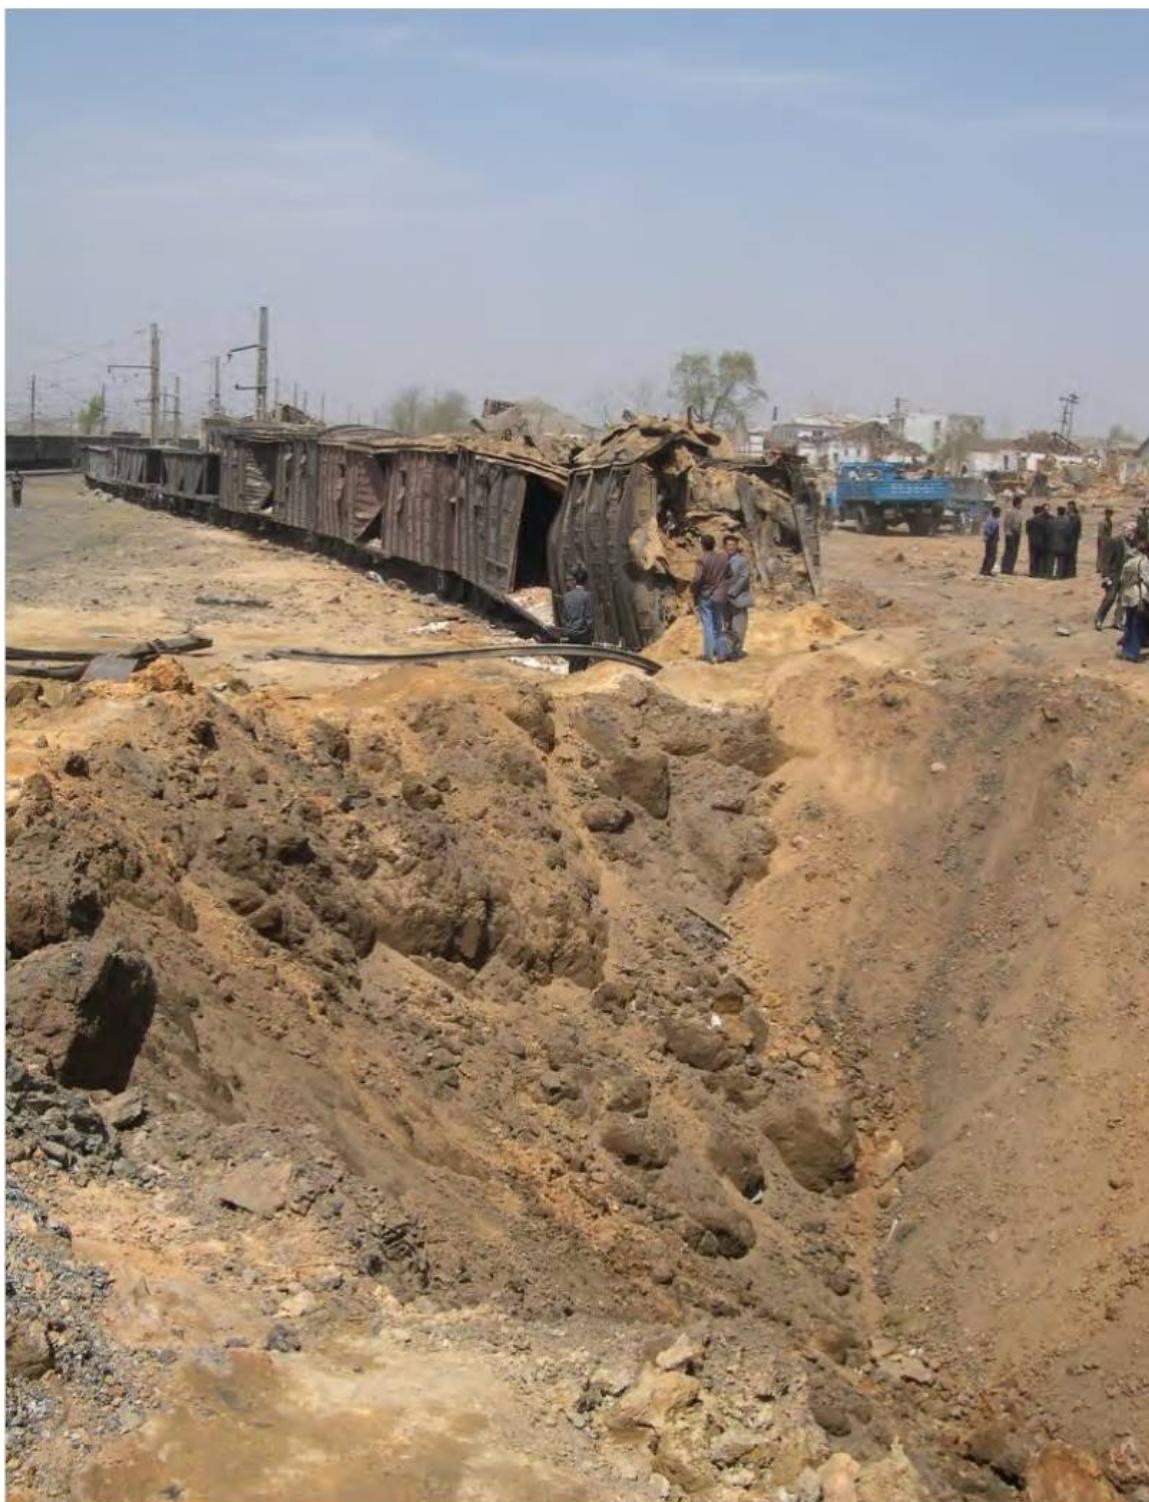
- **Ryongchon, North, Korea, 22 April 2004, 162 fatalities.** On 22 April 2004, there was a large explosion at the train station in the town of Ryongchon, North Korea. A freight train carrying AN exploded in this important railway town near the Chinese border. The explosion occurred during shunting operations at the railyard. Two cars each containing 40 tonnes (44 tons) of AN came into contact with a car containing fuel oil. The massive explosion created a large crater 15 meters (49 feet) deep and leveled everything in a 500-meter (1,640-foot) radius. The cause of the accident was unclear but may have been initiated when the railcars came in contact with a live electrical wire. There were 162 fatalities, including 76 school children and 3,000 others were injured. The station was destroyed, as were most buildings within 500 meters (1,625 feet), and nearly 8,000 homes were destroyed or damaged. Damages have been estimated at 300 million euros. Another report said that there were two craters of about 10 meters (33 feet) in depth were seen at the site of the explosion. Figure 120 shows the crater, while Figure 121 shows the damage to the primary school.

FIGURE 120. Crater at the Ryongchon, North Korea  
Railyard Following Explosion.  
<http://www.cdc.gov/niosh/mining/UserFiles/works/pdfs/arorai.pdf>

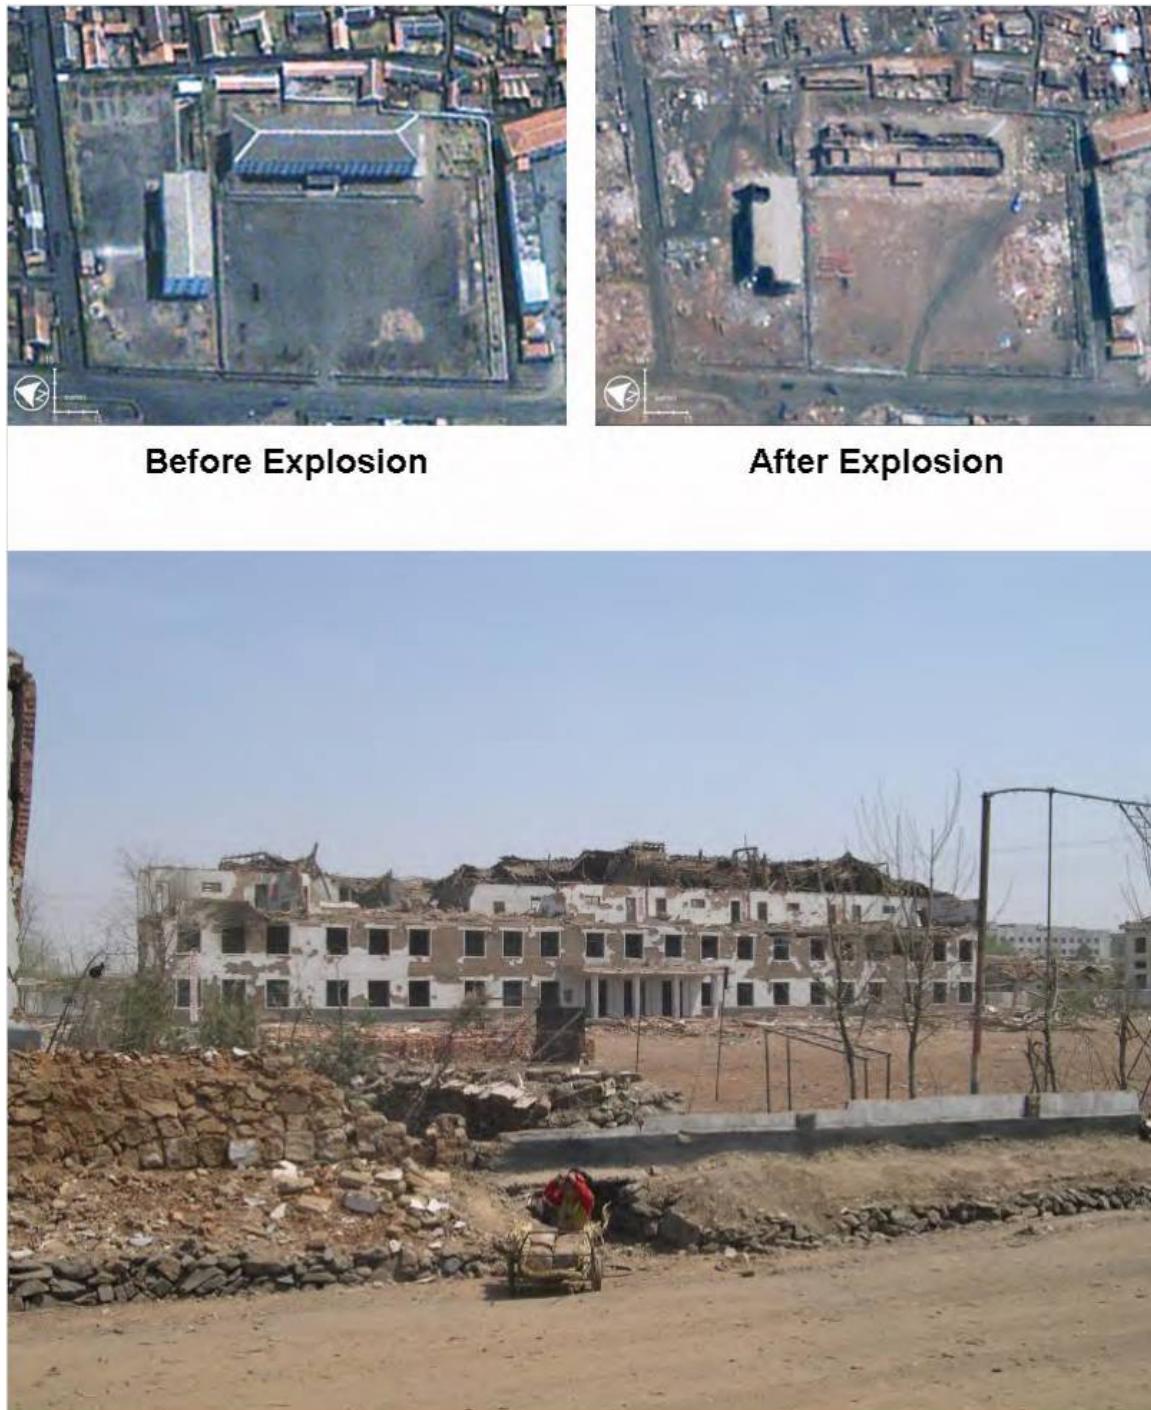
FIGURE 121. Damage to the Ryongchon Primary School.  
<http://www.cdc.gov/niosh/mining/pubs/pdfs/arorai.pdf>

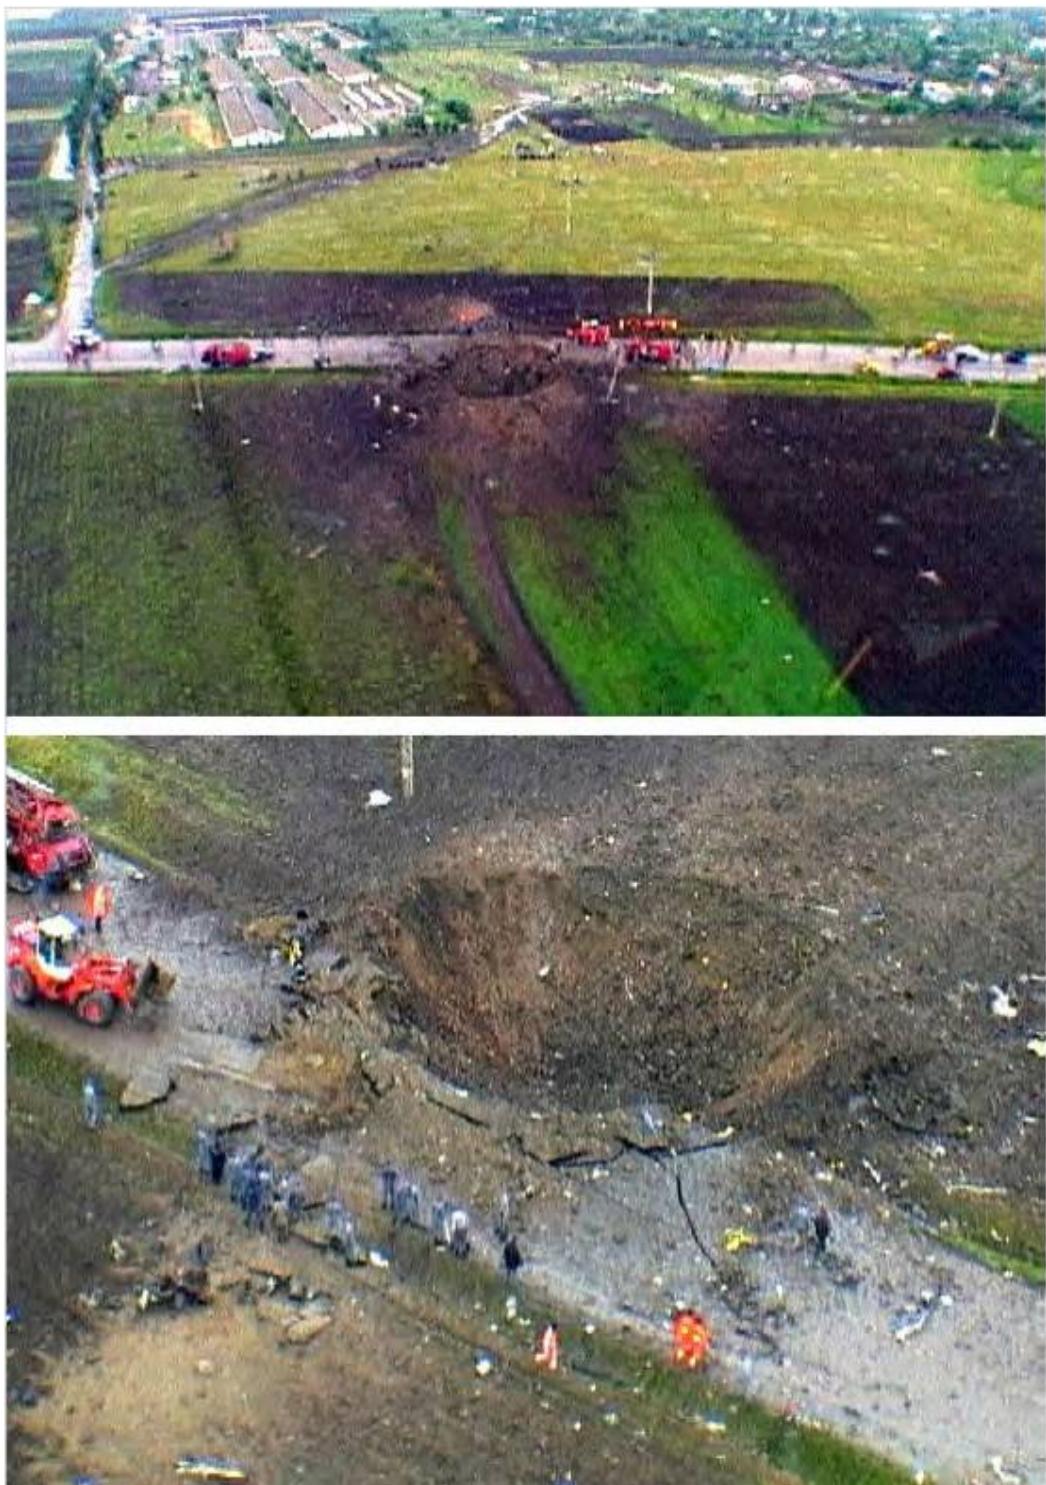
- **Mihăilești, Buzău, Romania, 24 May 2004, 20 fatalities.** A truck carrying more than 20 tonnes (22 tons) of AN tipped over and caught fire on the European road E85 near Mihăilești (50 kilometers (31 miles) northeast of Bucharest, Romania) at 4:57 a.m. on 24 May 2004. The driver tried to fight the fire. A few cars stopped and watched the fire. Two reporters got to the site of the accident and started filming the fire. Firefighters arrived and started to fight the fire. The last mistake of untrained Romanian firemen occurred when water was used in an attempt to extinguish burning chemicals (all firefighting instructions indicate not to use water but carbon dioxide (CO<sub>2</sub>) in case of burning chemicals and/or fuel). Around 5:50 a.m., the truck blew up, killing 20 and wounding 13 people. A crater 6.5 meters (21 feet) deep and 42 meters (137 feet) in diameter was formed by the explosion. Once again, the fire burned a significant time (enough time to get television film crews to the site) before the explosion took place. Figure 122 presents the scene after the accident.

FIGURE 122. Accident in Romania in Which 20 Tonnes (22 Tons) of “Nitrous Fertilizer” Caught Fire and Later Exploded, Killing 20 People.  
<http://www.cdc.gov/niosh/mining/UserFiles/works/pdfs/arorai.pdf>

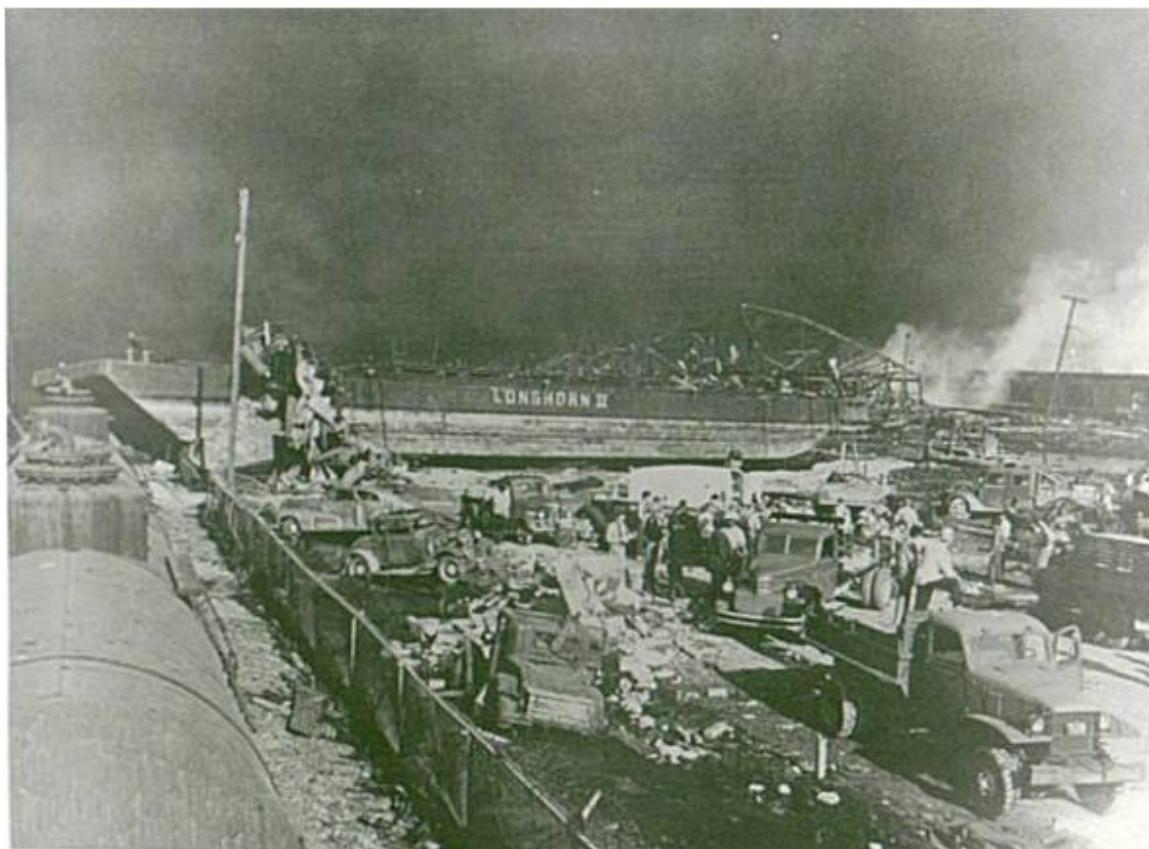
some said 5 seconds—by the AN in hold 2) disintegrated the *Grandcamp* sending lethal fragments and blast waves into workers, firemen, and the crowd of onlookers. The explosion blew almost 6,350 tons of the ship's steel into the air. Fragments from the *Grandcamp*, some weighing several tons, showered down throughout the port and town extending the range of casualties and damage well into the business district a mile away. For example, the *Grandcamp*'s 2-ton anchor was hurled 1.62 miles (2.61 kilometers) while the 5-ton anchor was hurled  $\frac{1}{2}$  mile (800 meters). At the Monsanto plant, located across the slip, 145 of 450 shift workers perished. The tremendous blast sent a 15-foot high wave that carried a 150-foot long x 28-foot wide x 11-foot deep barge, the *Longhorn II*, about 200 feet inland as shown in Figure 125.

FIGURE 125. Barge *Longhorn II* was Picked up and Carried About 200 Feet Inland by the Tidal Wave Caused by the Blast Caused by the Explosion of the *Grandcamp*.

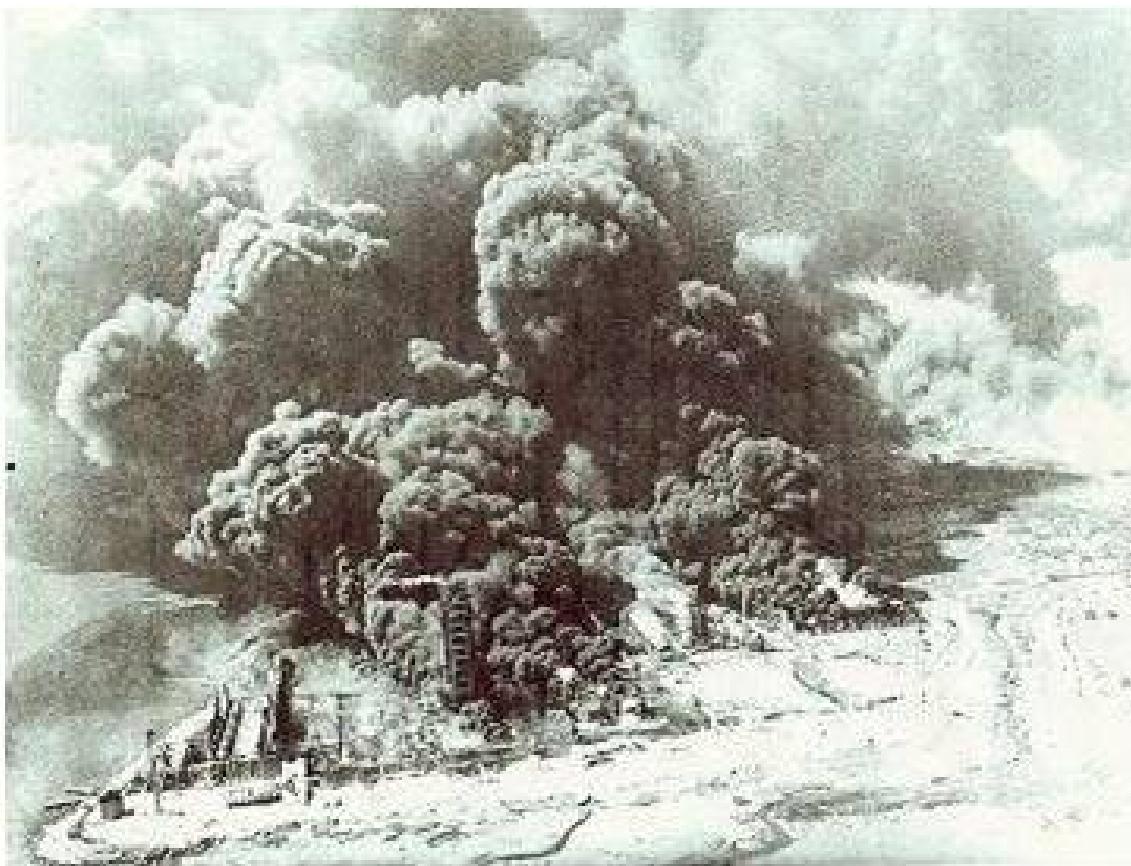
Flames quickly spread, helped by the burning bales of sisal and cotton, to the Monsanto plant and the nearby refineries (Figure 126).

FIGURE 126. Burning Following the Detonation  
on the *Grandcamp* at Texas City.
